# SYLWRAP Case Study

## Sprinkler System Pinhole Leak Pipe Repair

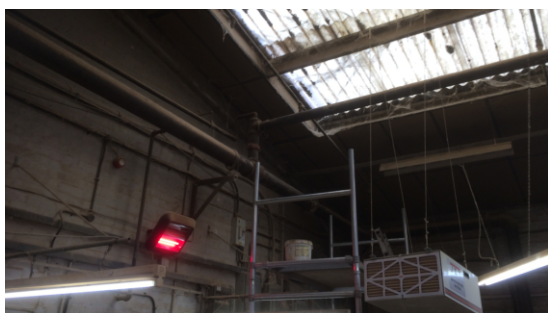
*The tee junction was located high in the roof of the factory, making access difficult*

The pinhole leak was on a steel pipe tee located high in the roof of the factory, close to the incoming electrics.

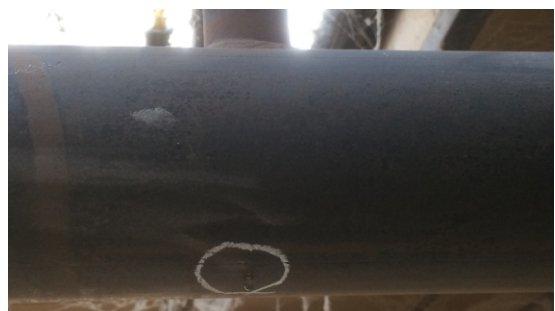
The sprinkler system maintenance company had tried to repair the pipe with a clamp, but the tee made this impossible, leading them to recommend a section replacement as the only solution.

*The pinhole leak was located underneath a tee, ruling out a repair using a clamp*

A tower was used to reach the damaged pipe and **Superfast Steel Epoxy Putty** applied, plugging the pinhole to seal the leak in under 10 minutes.

The repair was completed with a **SylWrap HD Pipe Repair Bandage** which was wrapped over the pinhole and around the tee to provide maximum reinforcement.

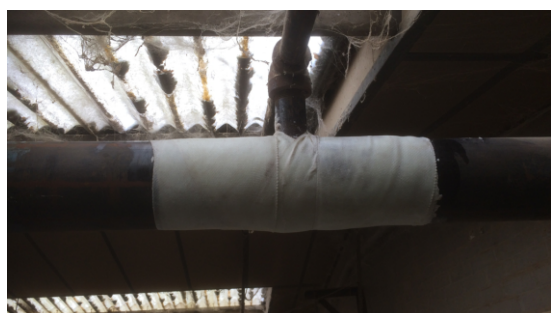
*The completed repair carried out using Superfast Steel Epoxy and SylWrap HD Pipe Repair Bandage*

Within an hour of the repair being completed, the system was put back into service at a fraction of the cost of the section replacement which had initially been recommended by the maintenance company.
